Detecting Patched Bullet Holes in Painted Drywall

Tom Adair & Charles S. DeFrance^a

^aFederal Bureau of Investigation, Denver Division

Citation: Adair, T. & DeFrance, C.S. (2011). Detecting Patched Bullet Holes in Painted Drywall. *Journal of the Association for Crime Scene Reconstruction*, 17(3), 29-35.

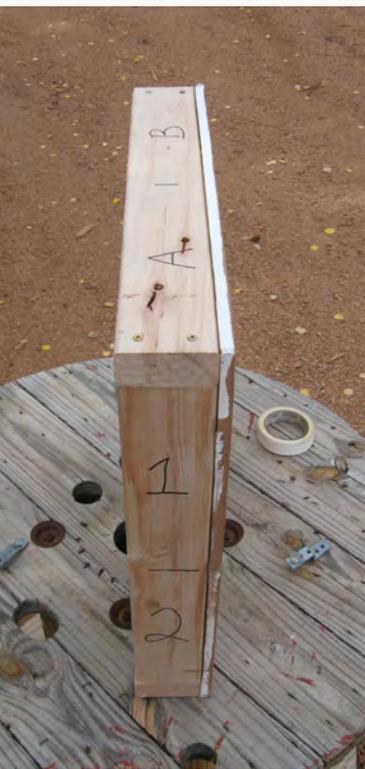
▲ **Figure 1:** Side view of test wall showing grid designations.

In order to investigate possible detection methods of patched bullet holes the authors constructed a twenty-four inch (61 cm) wall. The wall was constructed of half-inch (1 cm) drywall framed with two-inch by four-inch (5x10 cm) pine studs. The drywall was painted with two coats of Kilz® primer followed by two coats of brown colored KWAL® interior latex paint following manufacturer's recommended drying times. No texturing was done on the wall. The wall was then divided into four equal twelve-inch square (30 cm²) sections: 1A, 1B, 2A, and 2B (figure 1).

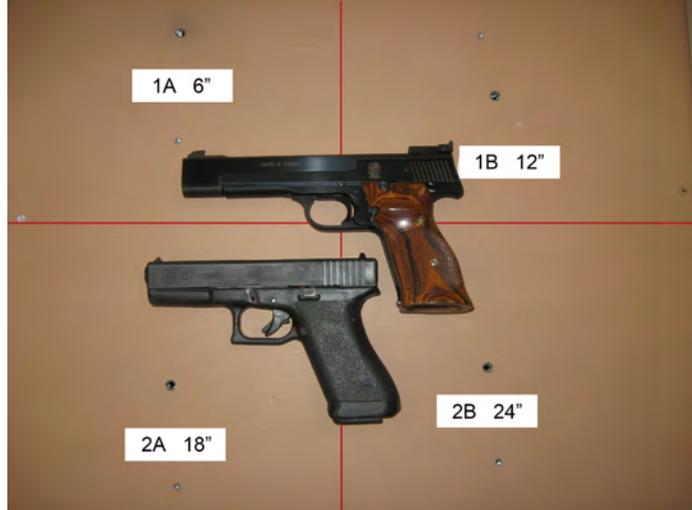
▶ **Figure 2 (upper right):** Test wall 1 with one 9mm bullet hole and one .22 caliber bullet hole in each grid square. The pistols used are also pictured.

Two handguns were used to create the bullet defects. A .22 caliber Smith and Wesson Model 41 pistol and a 9mm Luger (9x19mm) Glock Model 17 pistol. Ammunition used was Remington .22 long rifle (LR) caliber cartridges loaded with a 36-grain hollow-point bullet and Remington 9mm Luger (9x19mm) cartridges loaded with a 115-grain full metal jacket bullet. The calibers were selected for commonality in the market place. Fired shots were made approximately orthogonal to the wall. This was done to create the smallest defect possible for detection. A single shot from each weapon was made into each twelve-inch unit. By design, the fired bullets passed completely through the drywall and were not embedded in the pine wood studs. The authors also wanted to test the feasibility of recovering gunshot residue evidence by removing layers of paint after any defect detection. Authors varied the range of the shots to the wall from six to twenty four inches (15-61 cm) (figures 2 & 3), which resulted in visible gunshot residues on the painted drywall.

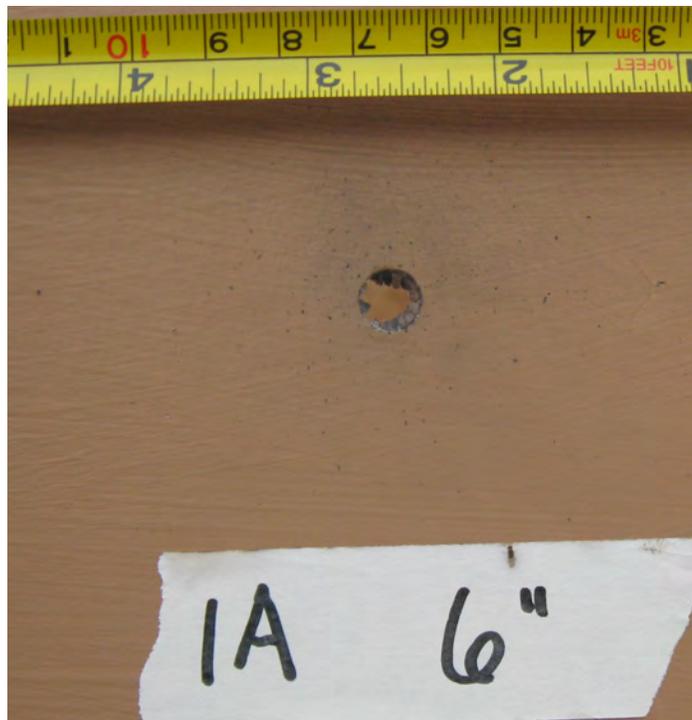
▶ **Figure 3:** Close-up of gunshot residue around 9mm bullet hole produced with a muzzle-to-target distance of about 6 inches (15cm) in grid 1A, test wall 1.

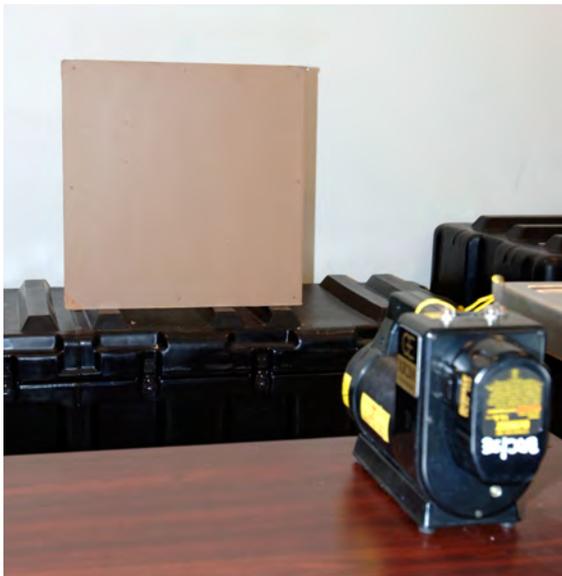
◀ **Figure 4: X-ray set-up showing x-ray source in foreground and test wall 1 with patched bullet holes in background.**

Two 8x17 inch image plates were placed behind the bullet defects with the x-ray source positioned perpendicular to the

drywall (figure 4). The manufacturer's software allowed technicians to stitch together two plate images to give a complete view of the wall (figure 5). The larger circles on the bottom of the image were pennies placed on the image plates for orientation purposes. The bullet defects were clearly visible using this method. Close inspection of the defects on the x-ray film revealed that the spackle was significantly lighter in color than the drywall, indicating that the spackle is more radio-opaque than the drywall. However, the centers of the toothpaste-patched holes were very close to the same color as the drywall. In both cases, a dark ring around the periphery of the defect further highlighted the holes on the x-ray images, which was particularly helpful in visualizing the toothpaste-filled holes. The cause of these dark rings was not immediately apparent, but was addressed in additional testing described below.

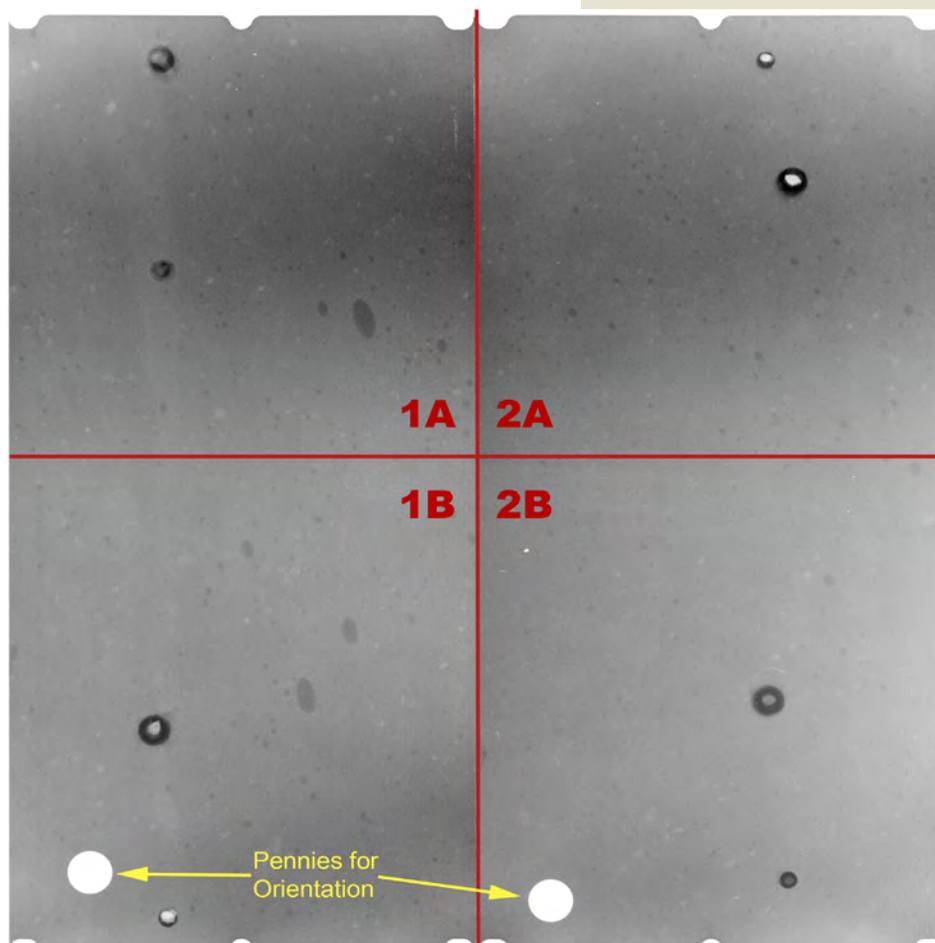
Figure 5: Stitched x-ray images from two plates showing bullet impacts from both 9mm and .22 caliber bullets. The large white circles in the lower left of each plate are pennies taped to the plate for orientation purposes.

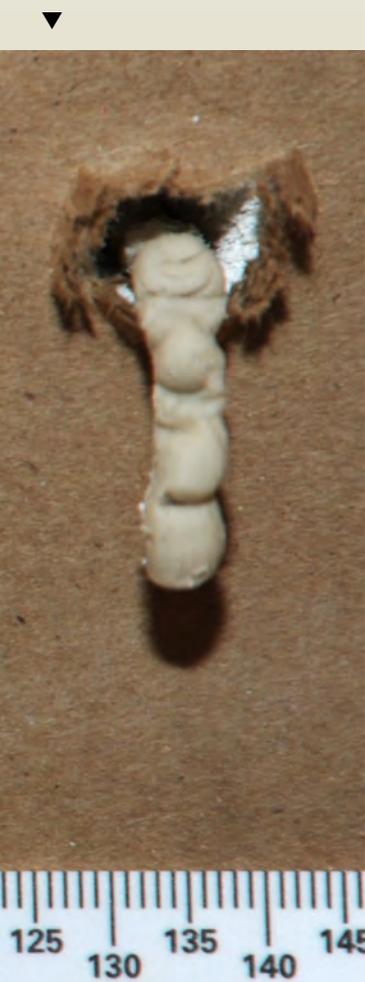
Figure 6: Plumber's putty extruded through the backside of the bullet hole during the patching process.

During this process, putty was extruded through the back of the hole and a ragged cylinder of putty hung from the back of the hole (figure 6). These fell off when the wall was moved for x-ray, but may still be present on an actual wall repaired in this fashion.

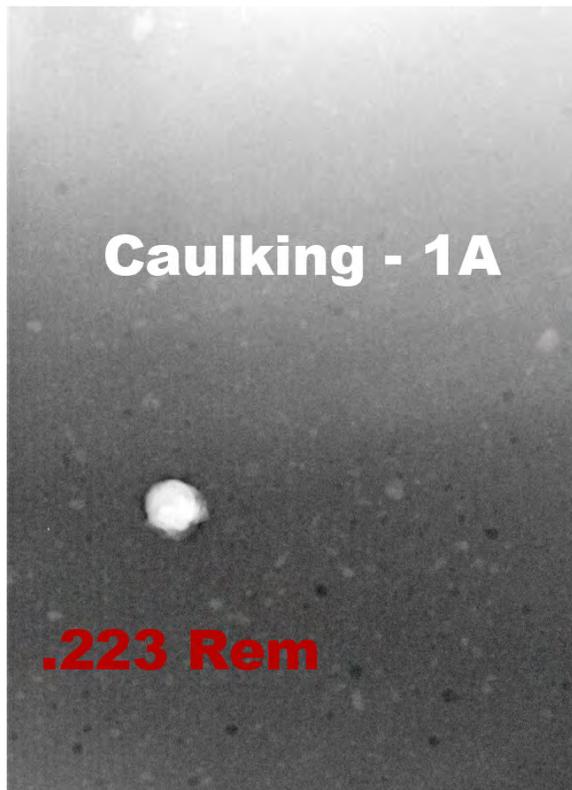
▲ Figure 7: X-ray image of bullet holes in grid 1A, test wall 2, which were patched with caulking.

All the quadrants were x-rayed as before using the Logos Digital Imaging System. When analyzed, it was found that the bullet holes were clearly visible regardless of the filler material used (figures 7-9). During the first round of x-rays, it was noticed that the bullet holes had a dark ring around their periphery. Dark portions of the x-ray depict areas where more x-rays are able to reach and expose the film. Therefore, the dark rings around the bullet defects indicated areas of lower density that permitted the passage of more x-rays than the surrounding drywall or the filler material. This same dark ring was observed in the x-ray images of the patched bullet holes in the second round of tests. A close examination of the rear of the drywall revealed an explanation. The bullets created a cone-shaped defect with the larger diameter of the cone on the exit side of the drywall. When patched from the entrance side, the filler material did not fill the greater diameter on the exit side of the defect that left an air gap (figure

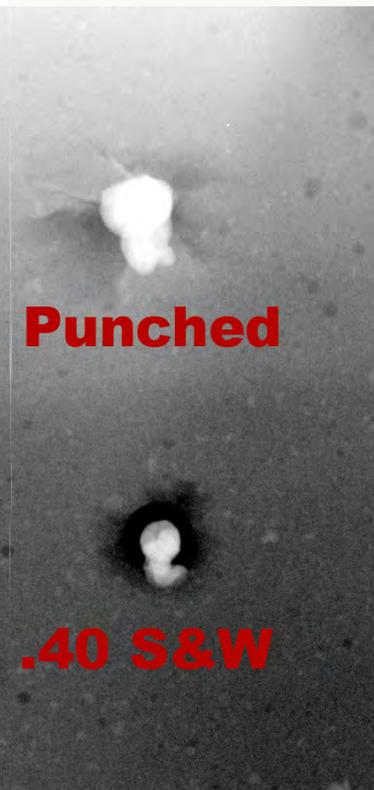
▶ **Figure 10:** The cone-shaped defect on the exit side of the drywall and the air gap between the borders of the crater and the patching material.

10). This air gap was the cause of the dark ring visible around the defects on the x-ray images. The x-ray image of the drilled hole showed only a thin, faint, partial ring that was clearly distinguishable from the bullet holes, likely because the hole had a uniform diameter and was more efficiently filled. The punched holes did have partial rings, but they were less distinct than the bullet holes. Though other mechanisms could result in cone-shaped defects that could also

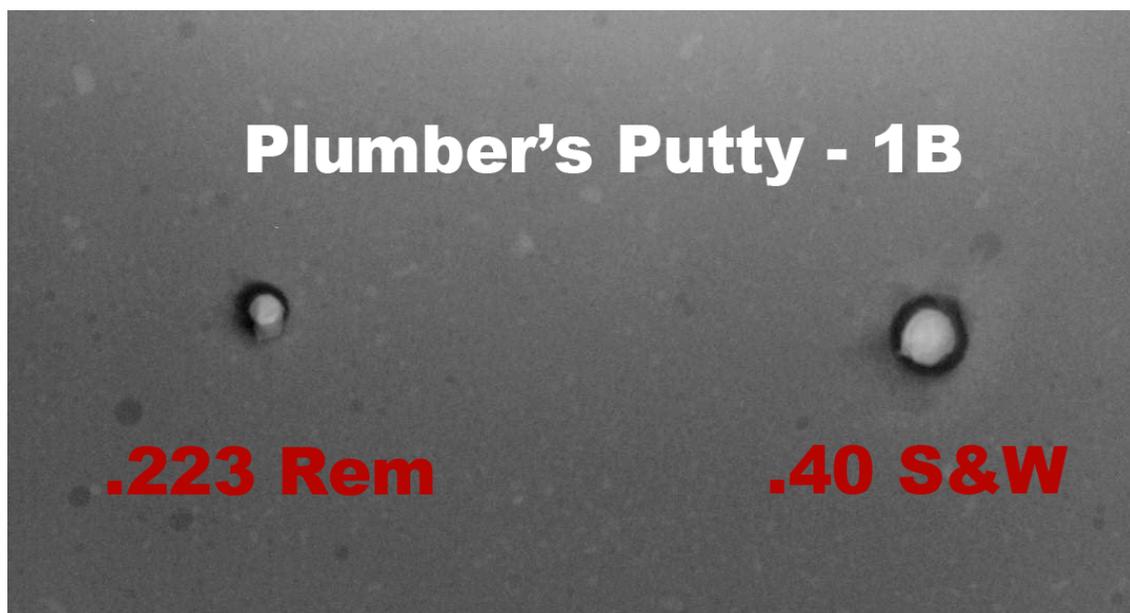
◀ Figure 8: X-ray image of bullet holes in grid 1B, test wall 2, which were patched with plumber's putty.

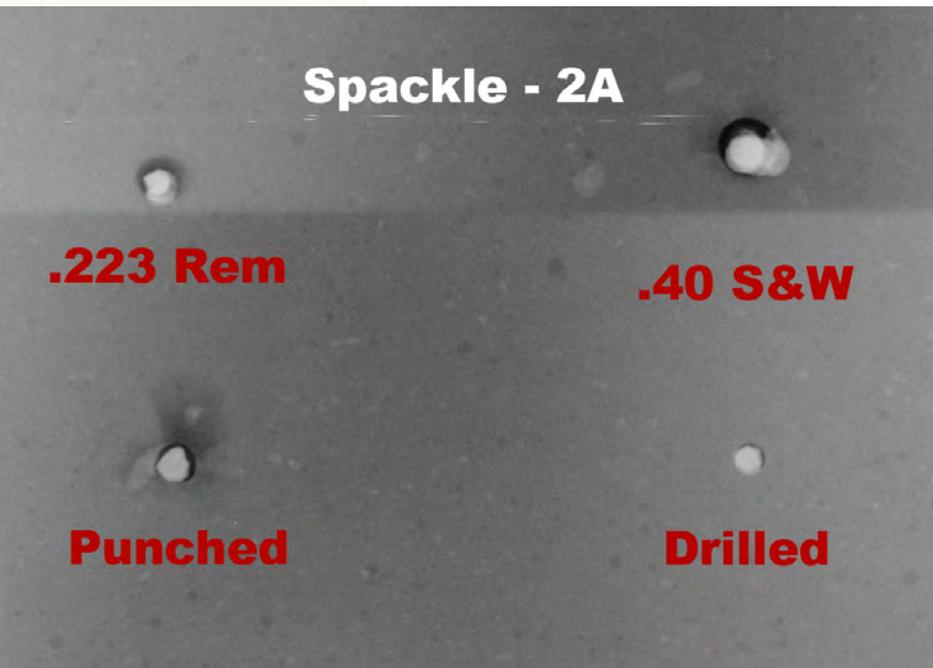
▲ **Figure 9:** X-ray image of bullet holes in grid 2A, test wall 2, which were patched with spackle.

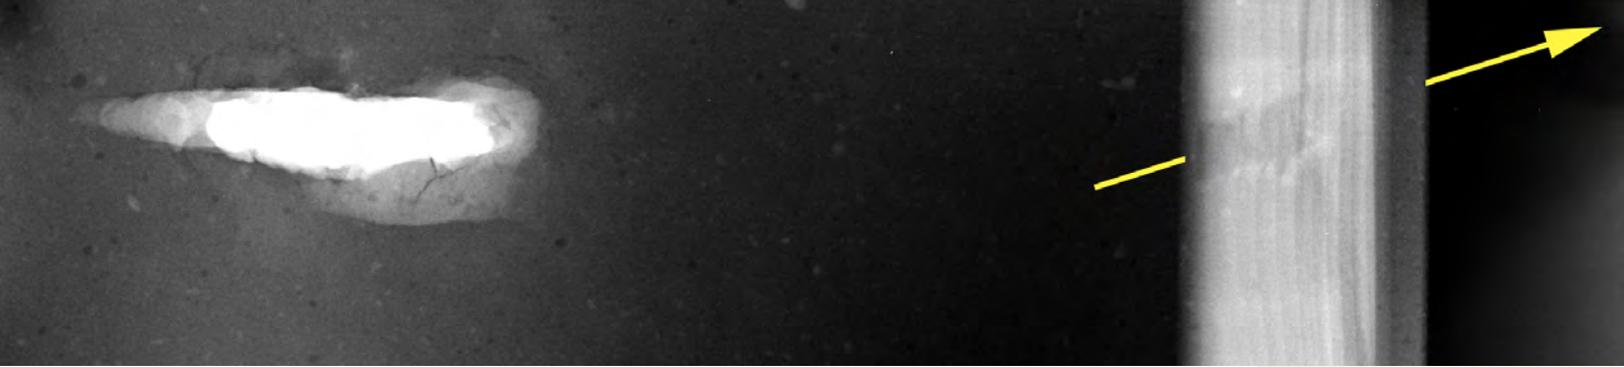
▲ **Figure 11: X-ray image of acutely impacting bullet hole in drywall and 2x4 board. An upward deflection is evident from the perforation of the board (front view).**

When x-raying the low angle impacts in quadrant 2B, the authors were interested in determining if the bullet path through the 2x4 board would be visible. It was found that the bullet path was faintly visible (figure 11) and it appeared to show an upward deflection. A trajectory rod was used to demonstrate this deflection, which was measured as a 12° upward deflection and a 20° lateral deflection (figure 12).

Bullet deflection during perforation is always a concern when conducting a trajectory analysis. Though not a focus of this study, the bullet deflection through the pine 2x4 board does highlight this issue. However, the alignment of the perforation through the drywall and the entrance impact in the board does result in an accurate extrapolation of the pre-impact trajectory of the bullet. Further probing of the board revealed the deflected bullet path that was far out of alignment with the original trajectory.

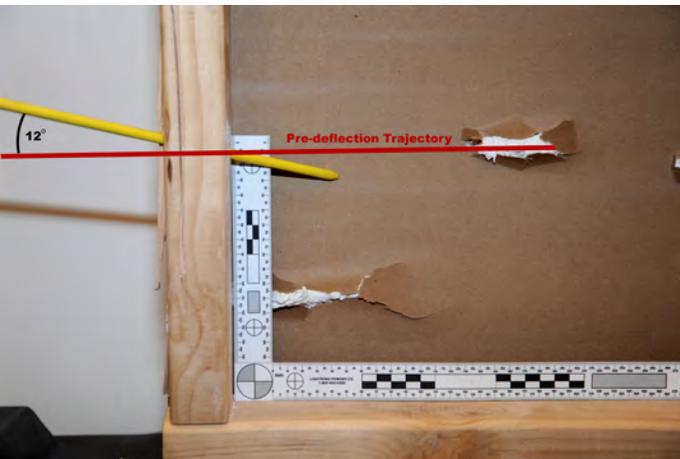
◀ **Figure 12: Probe (yellow) showing the deflected path of the bullet through the board and the pre-deflection trajectory shown in red (back view).**
